HISTORIC AMERICAN BUILDINGS SURVEY
INVENTORY

2. NAME *Orrin Thompson Mansion*

DATE OR PERIOD *1832*
STYLE *Greek Revival*
ARCHITECT
BUILDER *Orrin Thompson*

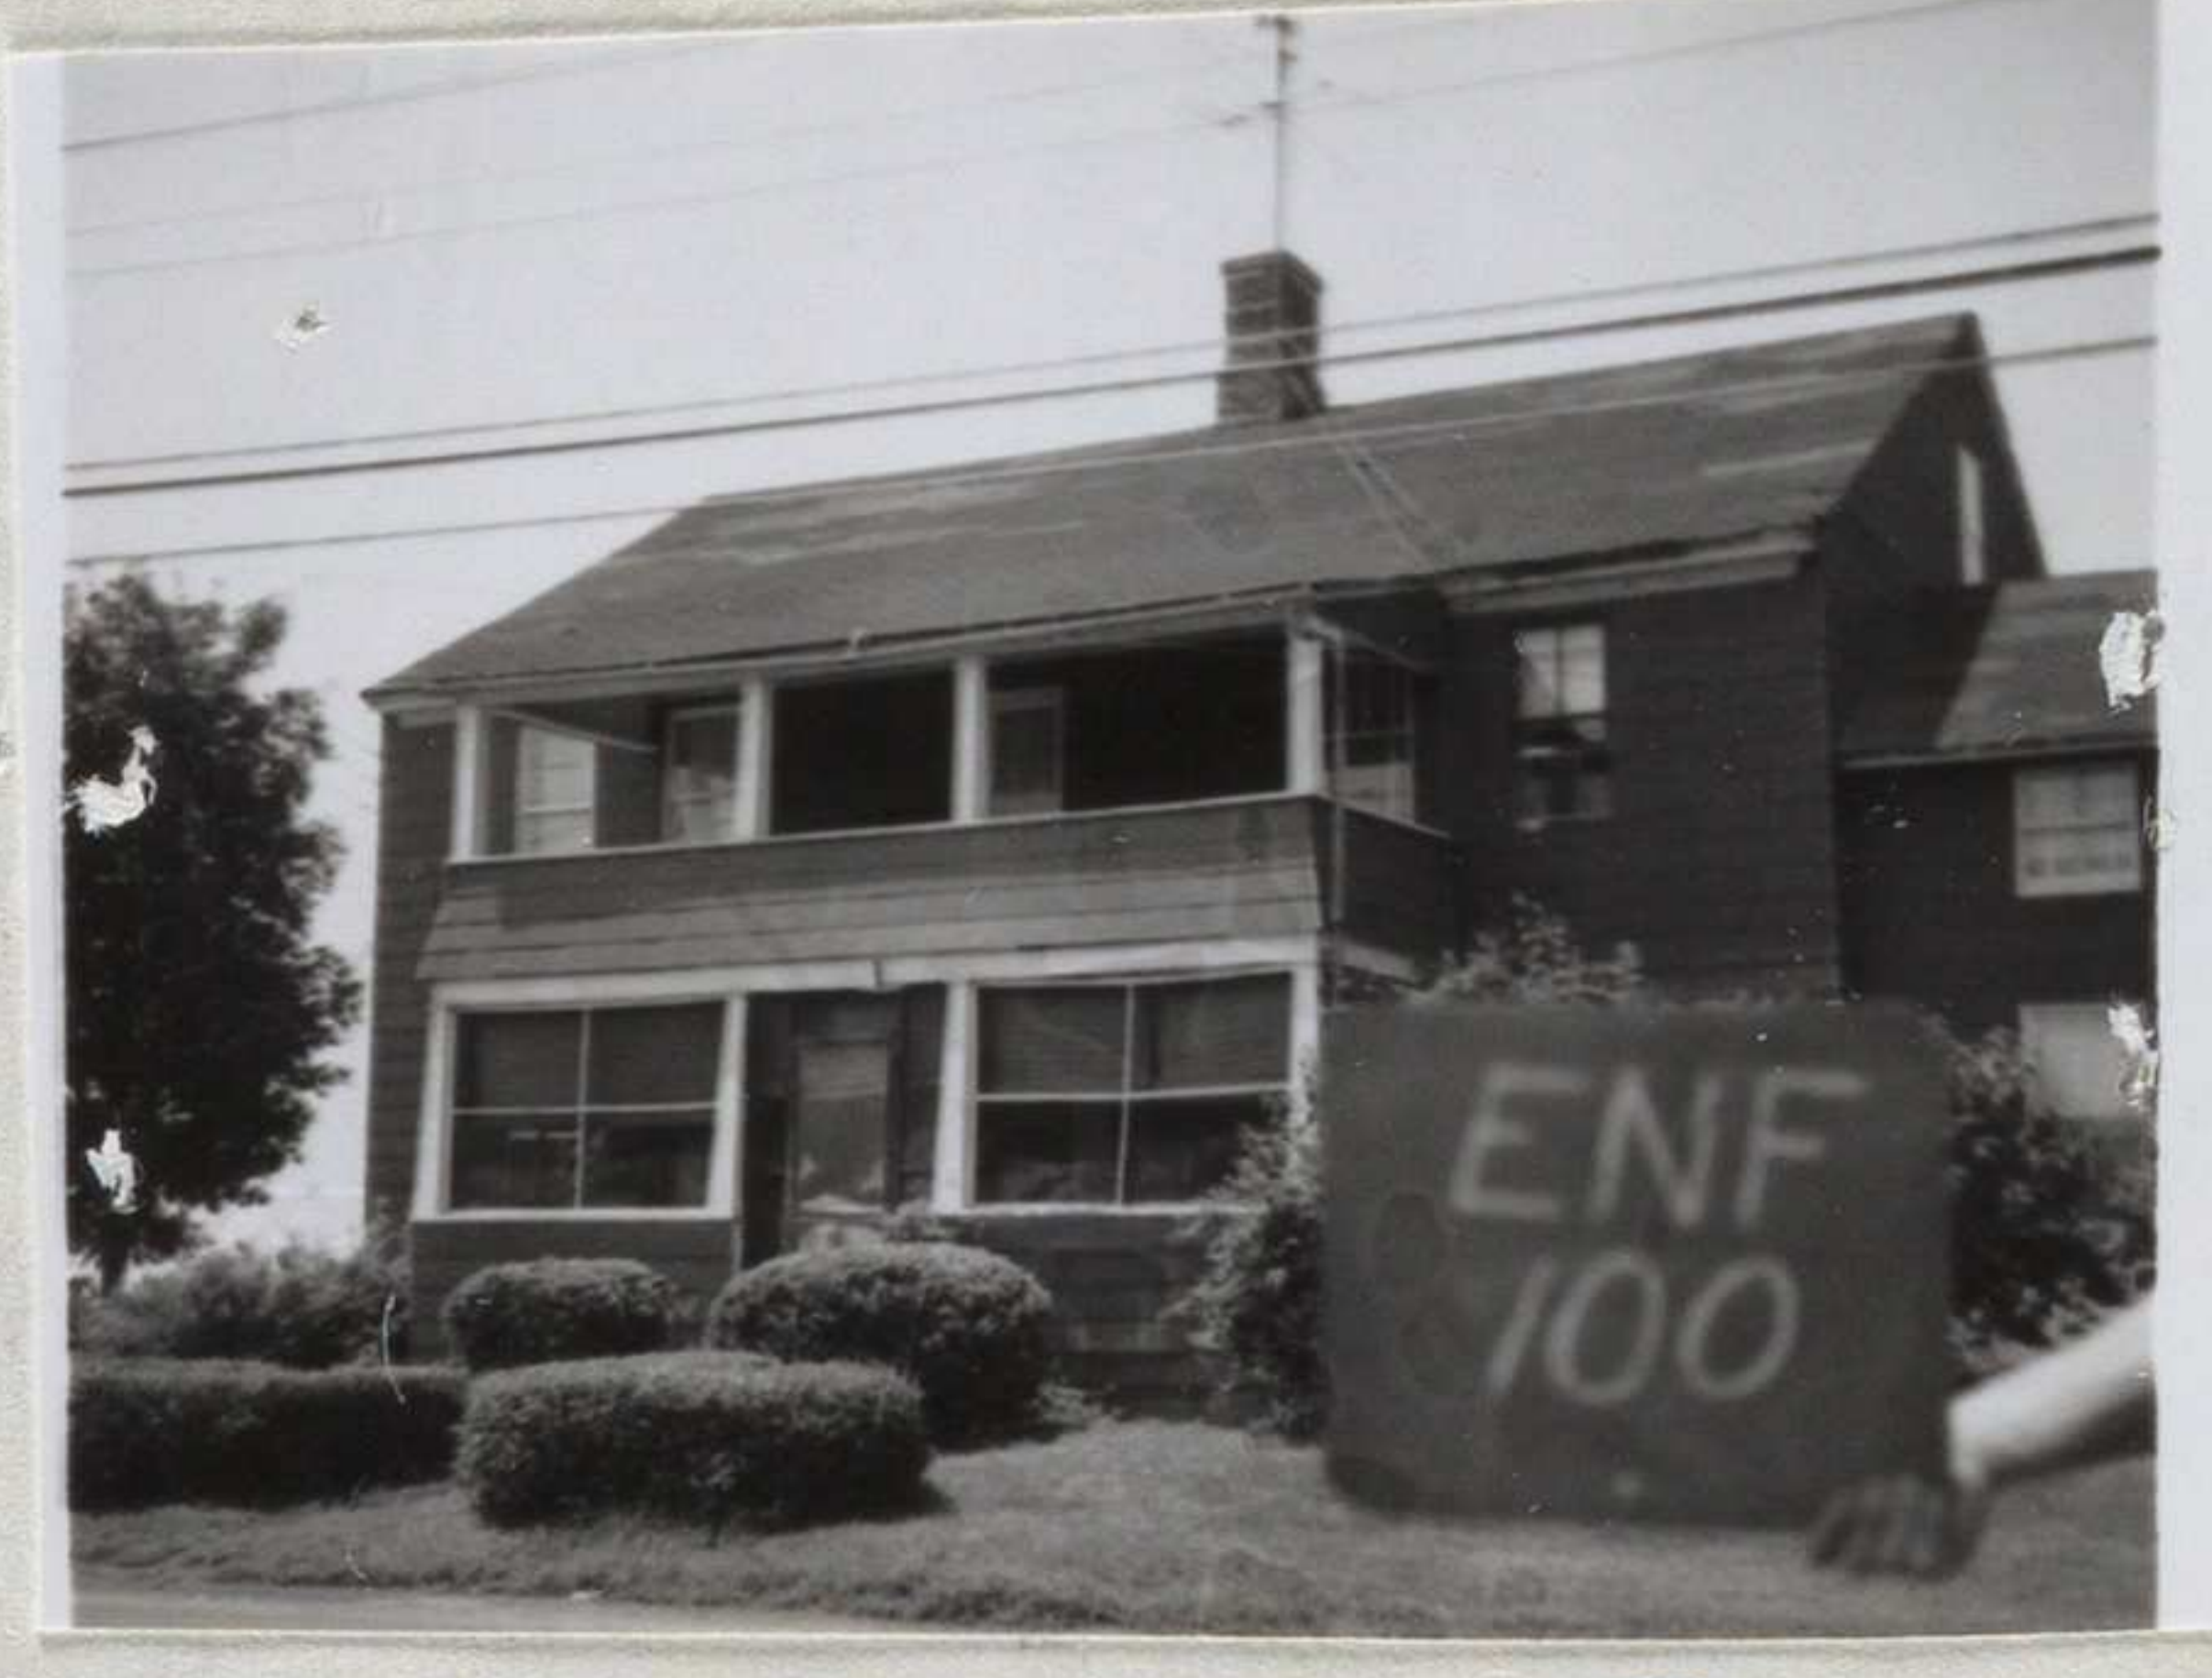
<p>7. PHOTOGRAPH <i>Enf 100</i></p>

<p>1. STATE <i>Ct</i> COUNTY <i>Hartford</i> TOWN <i>Enfield</i> VICINITY STREET NO. <i>Maple Street</i></p> <p>ORIGINAL OWNER ? ORIGINAL USE <i>Residence</i> PRESENT OWNER ? PRESENT USE <i>Residence</i> WALL CONSTRUCTION <i>Johns-Honsville</i> NO. OF STORIES <i>2</i></p>	<p>HISTORIC AMERICAN BUILDINGS SURVEY INVENTORY</p> <p>2. NAME</p> <p>DATE OR PERIOD <i>1750?</i> STYLE <i>Georgian Colonial</i> ARCHITECT BUILDER</p> <p>3. FOR LIBRARY OF CONGRESS USE</p>
<p>4. NOTABLE FEATURES, HISTORICAL SIGNIFICANCE AND DESCRIPTION</p> <p style="text-align: right;">OPEN TO PUBLIC <i>No</i></p> <p><i>Built on a brick foundation, this 5 bay house has a medium pitched roof set off with fine dentiling in the cornice. Neither the central chimney nor the windows are original, and the mid-19th century doorway probably replaced the original double doors. An attractive new porch and rear ell have been added.</i></p>

<p>5. PHYSICAL CONDITION OF STRUCTURE Endangered <i>!</i> Interior <i>poor</i> Exterior <i>poor</i></p>	
<p>6. LOCATION MAP (Plan Optional)</p>

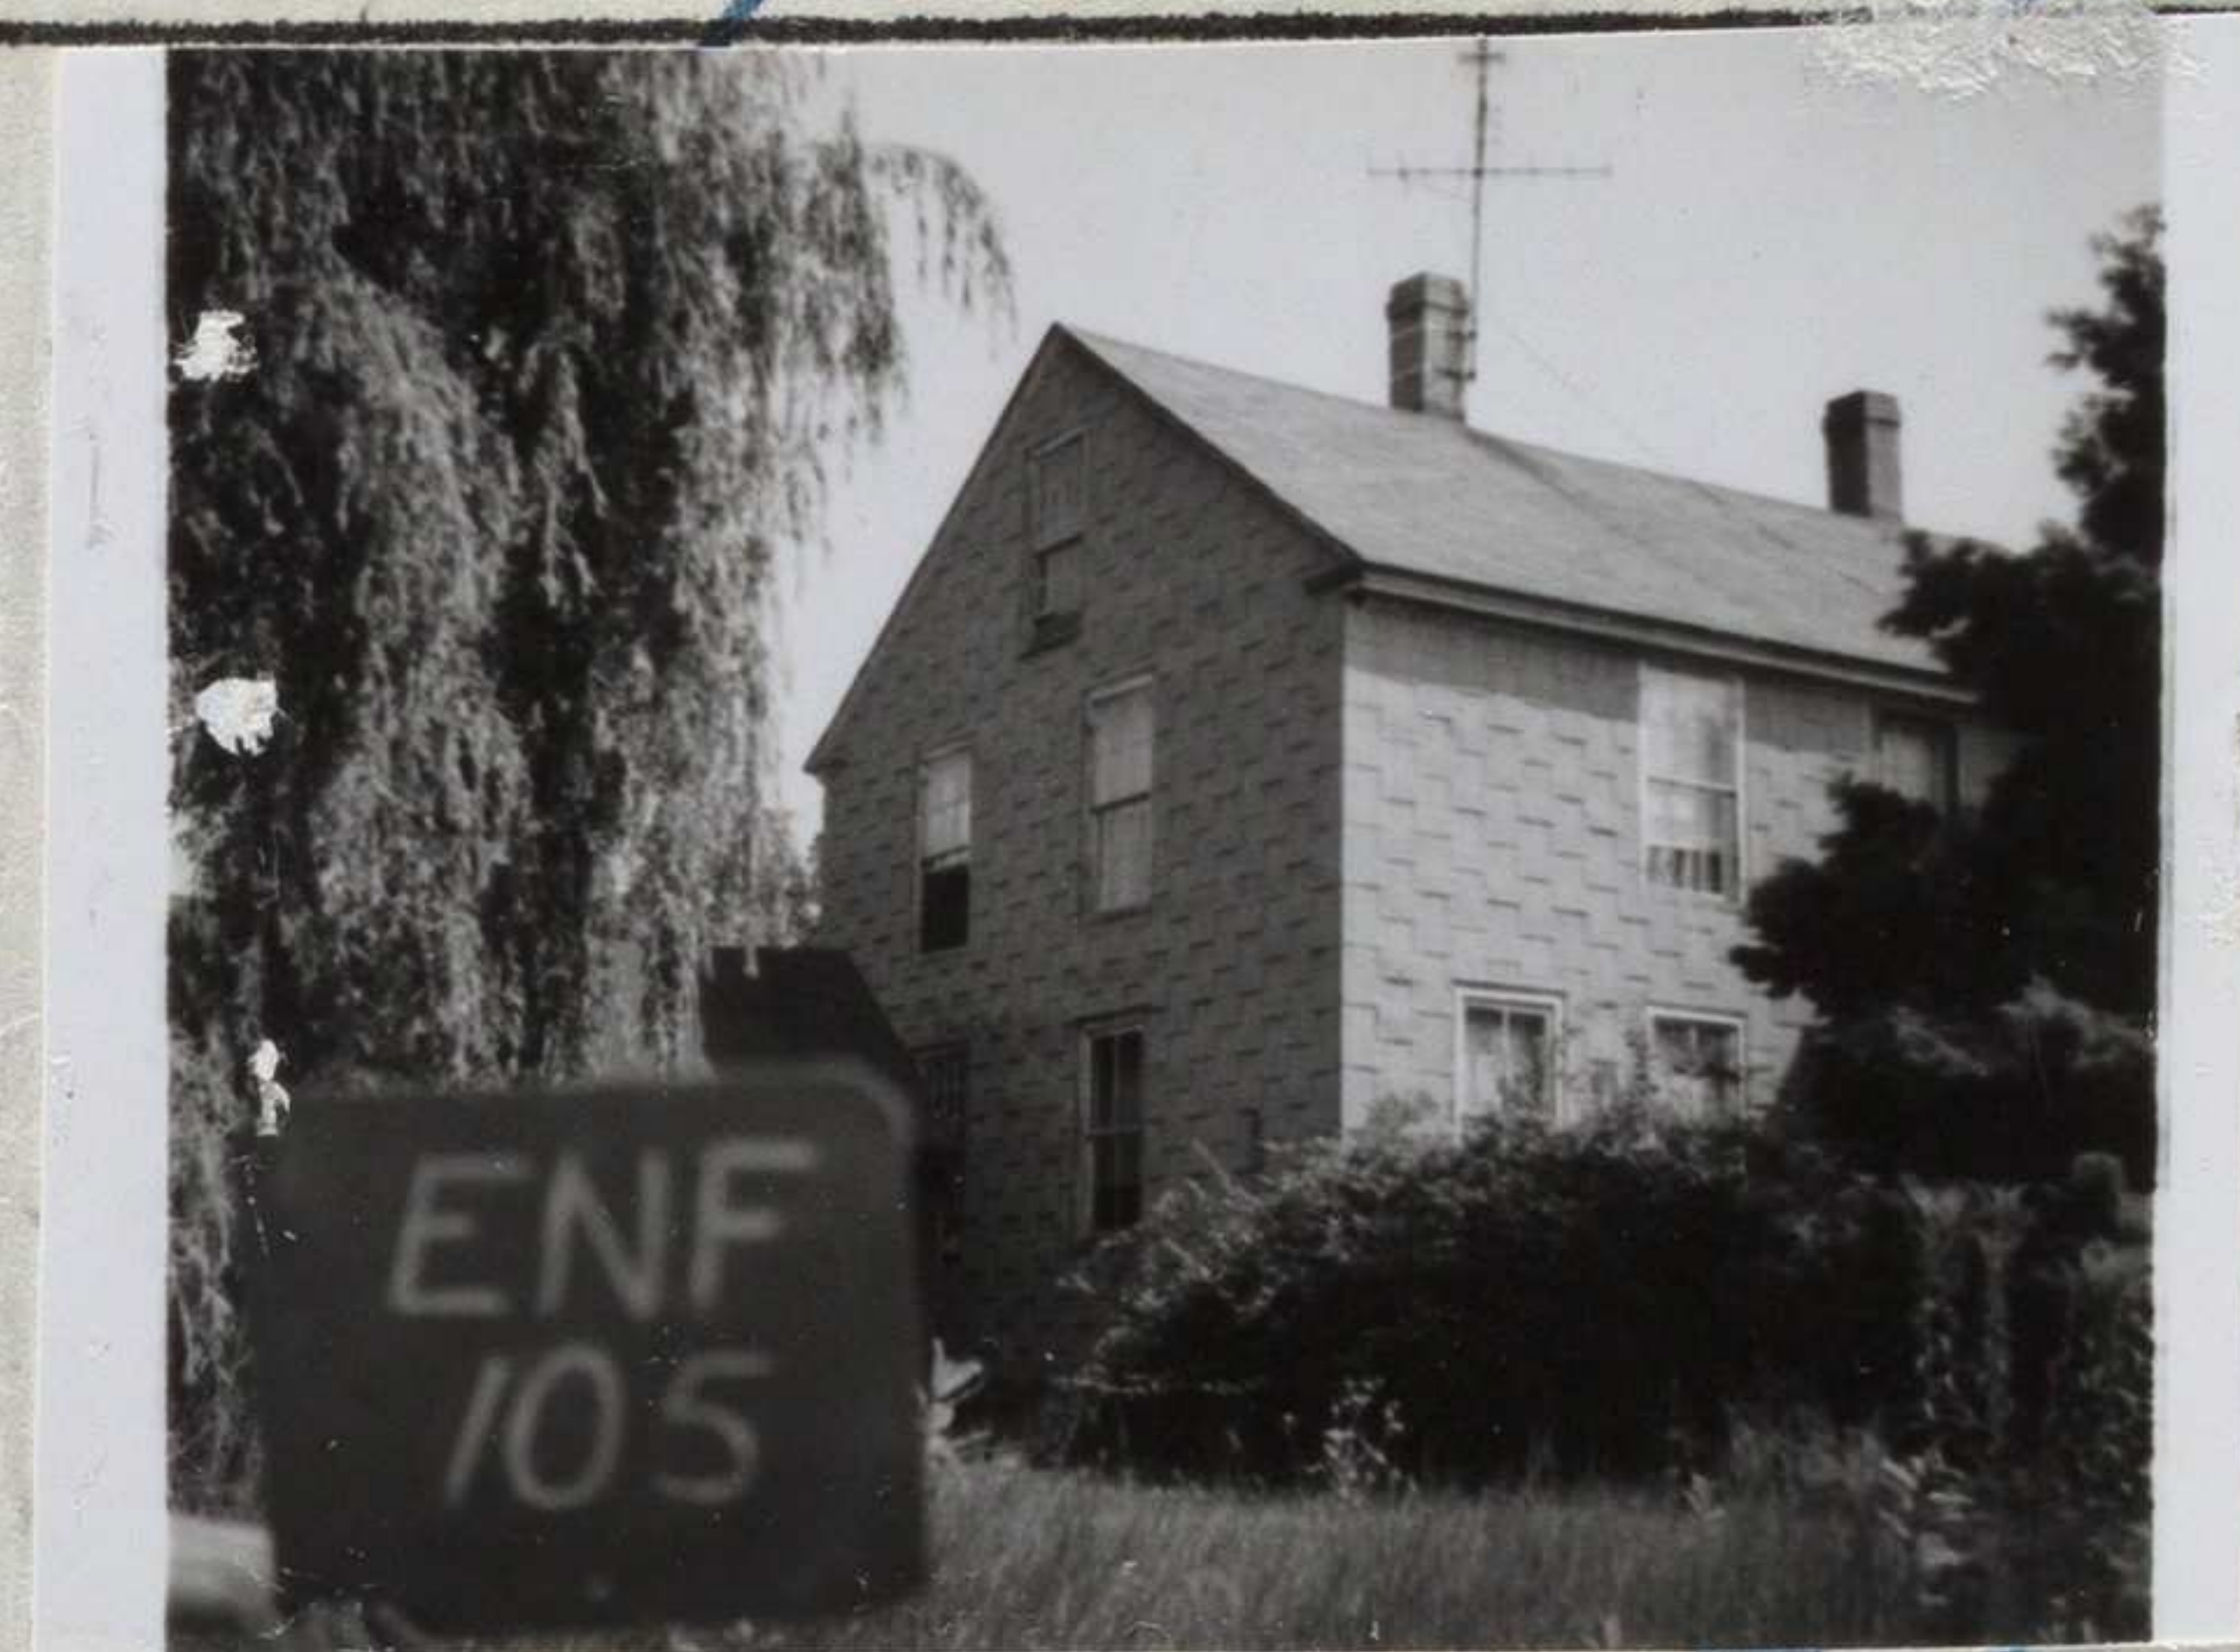
<p>7. PHOTOGRAPH <i>Enf 105</i></p>

<p>1. STATE <i>CC</i> COUNTY <i>Hartford</i> TOWN <i>Enfield</i> VICINITY STREET NO. <i>Cottage Road</i> ORIGINAL OWNER ? ORIGINAL USE <i>Residence</i> PRESENT OWNER ? PRESENT USE <i>Residence</i> WALL CONSTRUCTION <i>J. Mansville shingles</i> NO. OF STORIES <i>2</i></p>		<p>HISTORIC AMERICAN BUILDINGS SURVEY INVENTORY</p> <p>2. NAME DATE OR PERIOD <i>1780</i> STYLE <i>Georgian Colonial</i> ARCHITECT BUILDER</p> <p>3. FOR LIBRARY OF CONGRESS USE</p>	
<p>4. NOTABLE FEATURES, HISTORICAL SIGNIFICANCE AND DESCRIPTION</p> <p><i>Built on a brownstone foundation, this 5 bay (2 missing on the 2nd floor) has had most of its 12/12 windows replaced with 6/6. The molding is all that remains of the doorway. New chimneys are in the medium pitched roof. Other additions and bastardizations appear everywhere.</i></p>		<p>OPEN TO PUBLIC <i>No</i></p>	
<p>5. PHYSICAL CONDITION OF STRUCTURE</p> <p><i>Endangered ?</i> Interior <i>poor</i> Exterior <i>door</i></p>

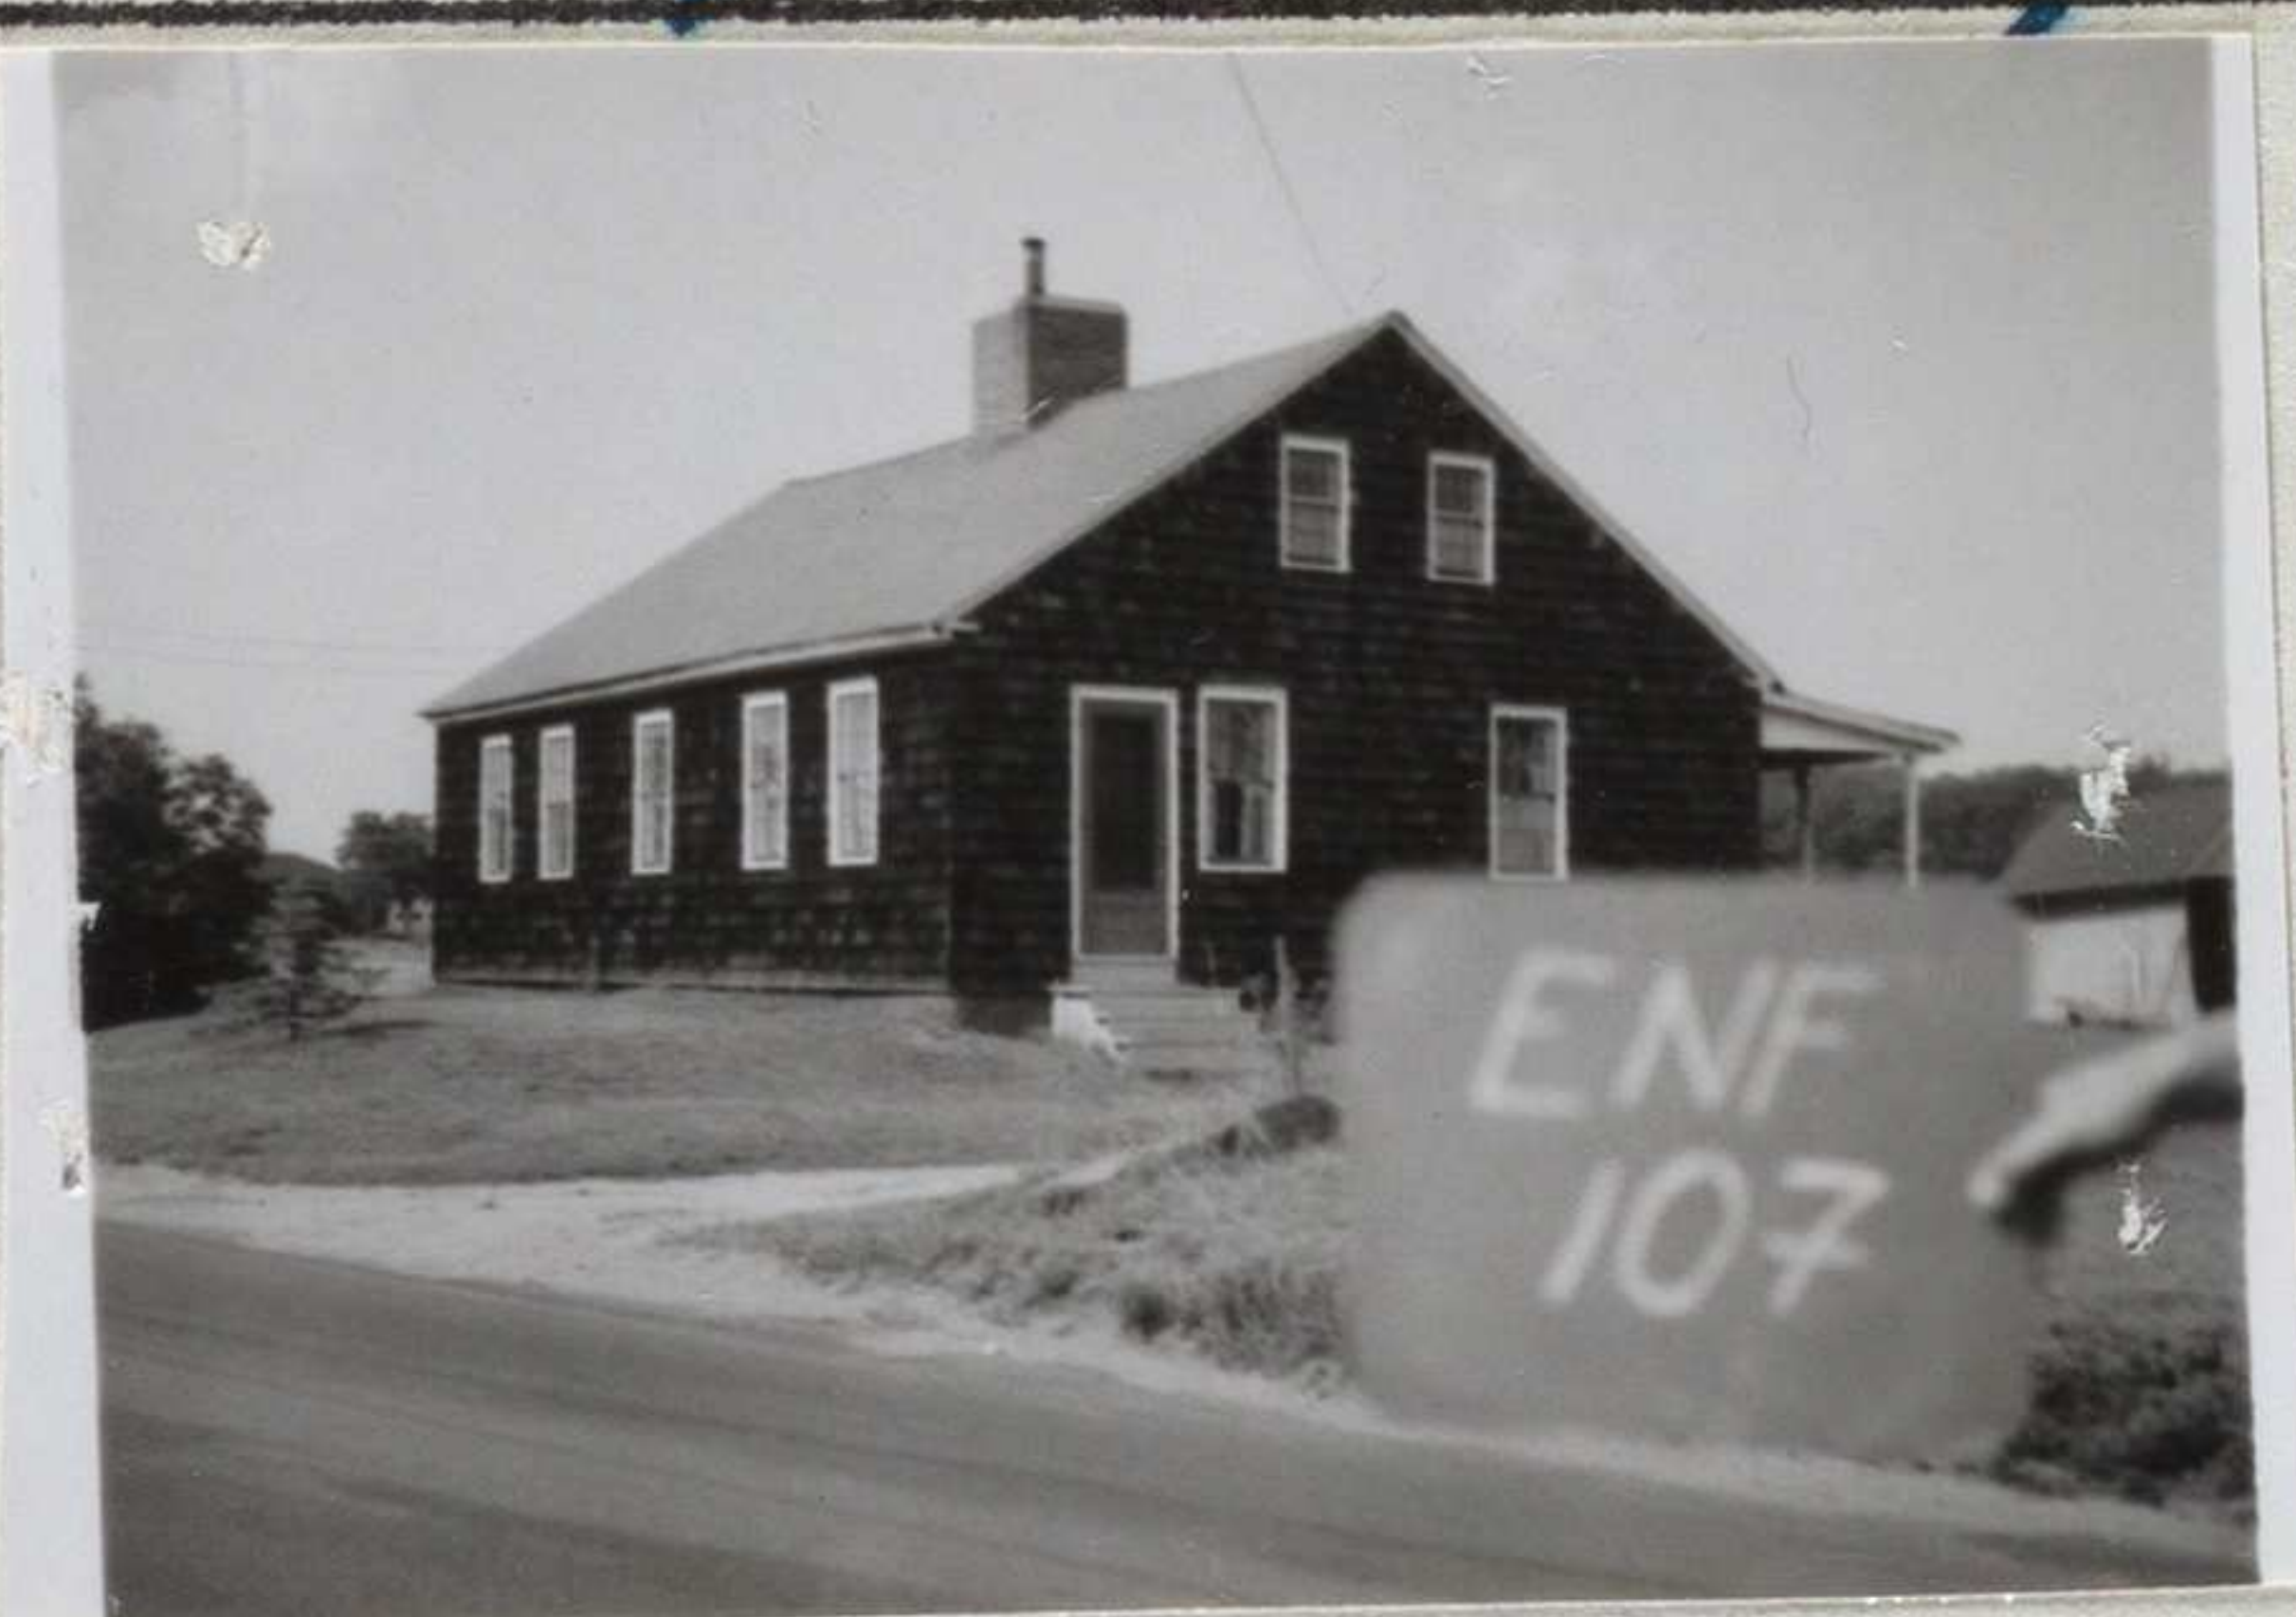
<p>7. PHOTOGRAPH <i>Enf 107</i></p>

<p>1. STATE <i>CT</i> COUNTY <i>Hartford</i> TOWN <i>Enfield</i> VICINITY STREET NO. <i>North Road</i></p> <p>ORIGINAL OWNER ? ORIGINAL USE <i>Residence</i> PRESENT OWNER ? PRESENT USE <i>Residence</i> WALL CONSTRUCTION <i>shingles</i> NO. OF STORIES 1</p>	<p>HISTORIC AMERICAN BUILDINGS SURVEY INVENTORY</p> <p>2. NAME</p> <p>DATE OR PERIOD <i>1780?</i> STYLE <i>Georgian Colonial</i> ARCHITECT BUILDER</p> <p>3. FOR LIBRARY OF CONGRESS USE</p>
<p>4. NOTABLE FEATURES, HISTORICAL SIGNIFICANCE AND DESCRIPTION</p> <p>OPEN TO PUBLIC <i>NO</i></p> <p><i>This old house is built on a brownstone foundation. Although the door bay of the five bay facade has been removed, the coffin door to the south remains. The windows are 6/6. The medium pitched roof has a large central chimney.</i></p>	
<p>5. PHYSICAL CONDITION OF STRUCTURE</p> <p>Endangered ? Interior <i>poor?</i> Exterior <i>poor</i></p> <p>6. LOCATION MAP (Plan Optional)</p>

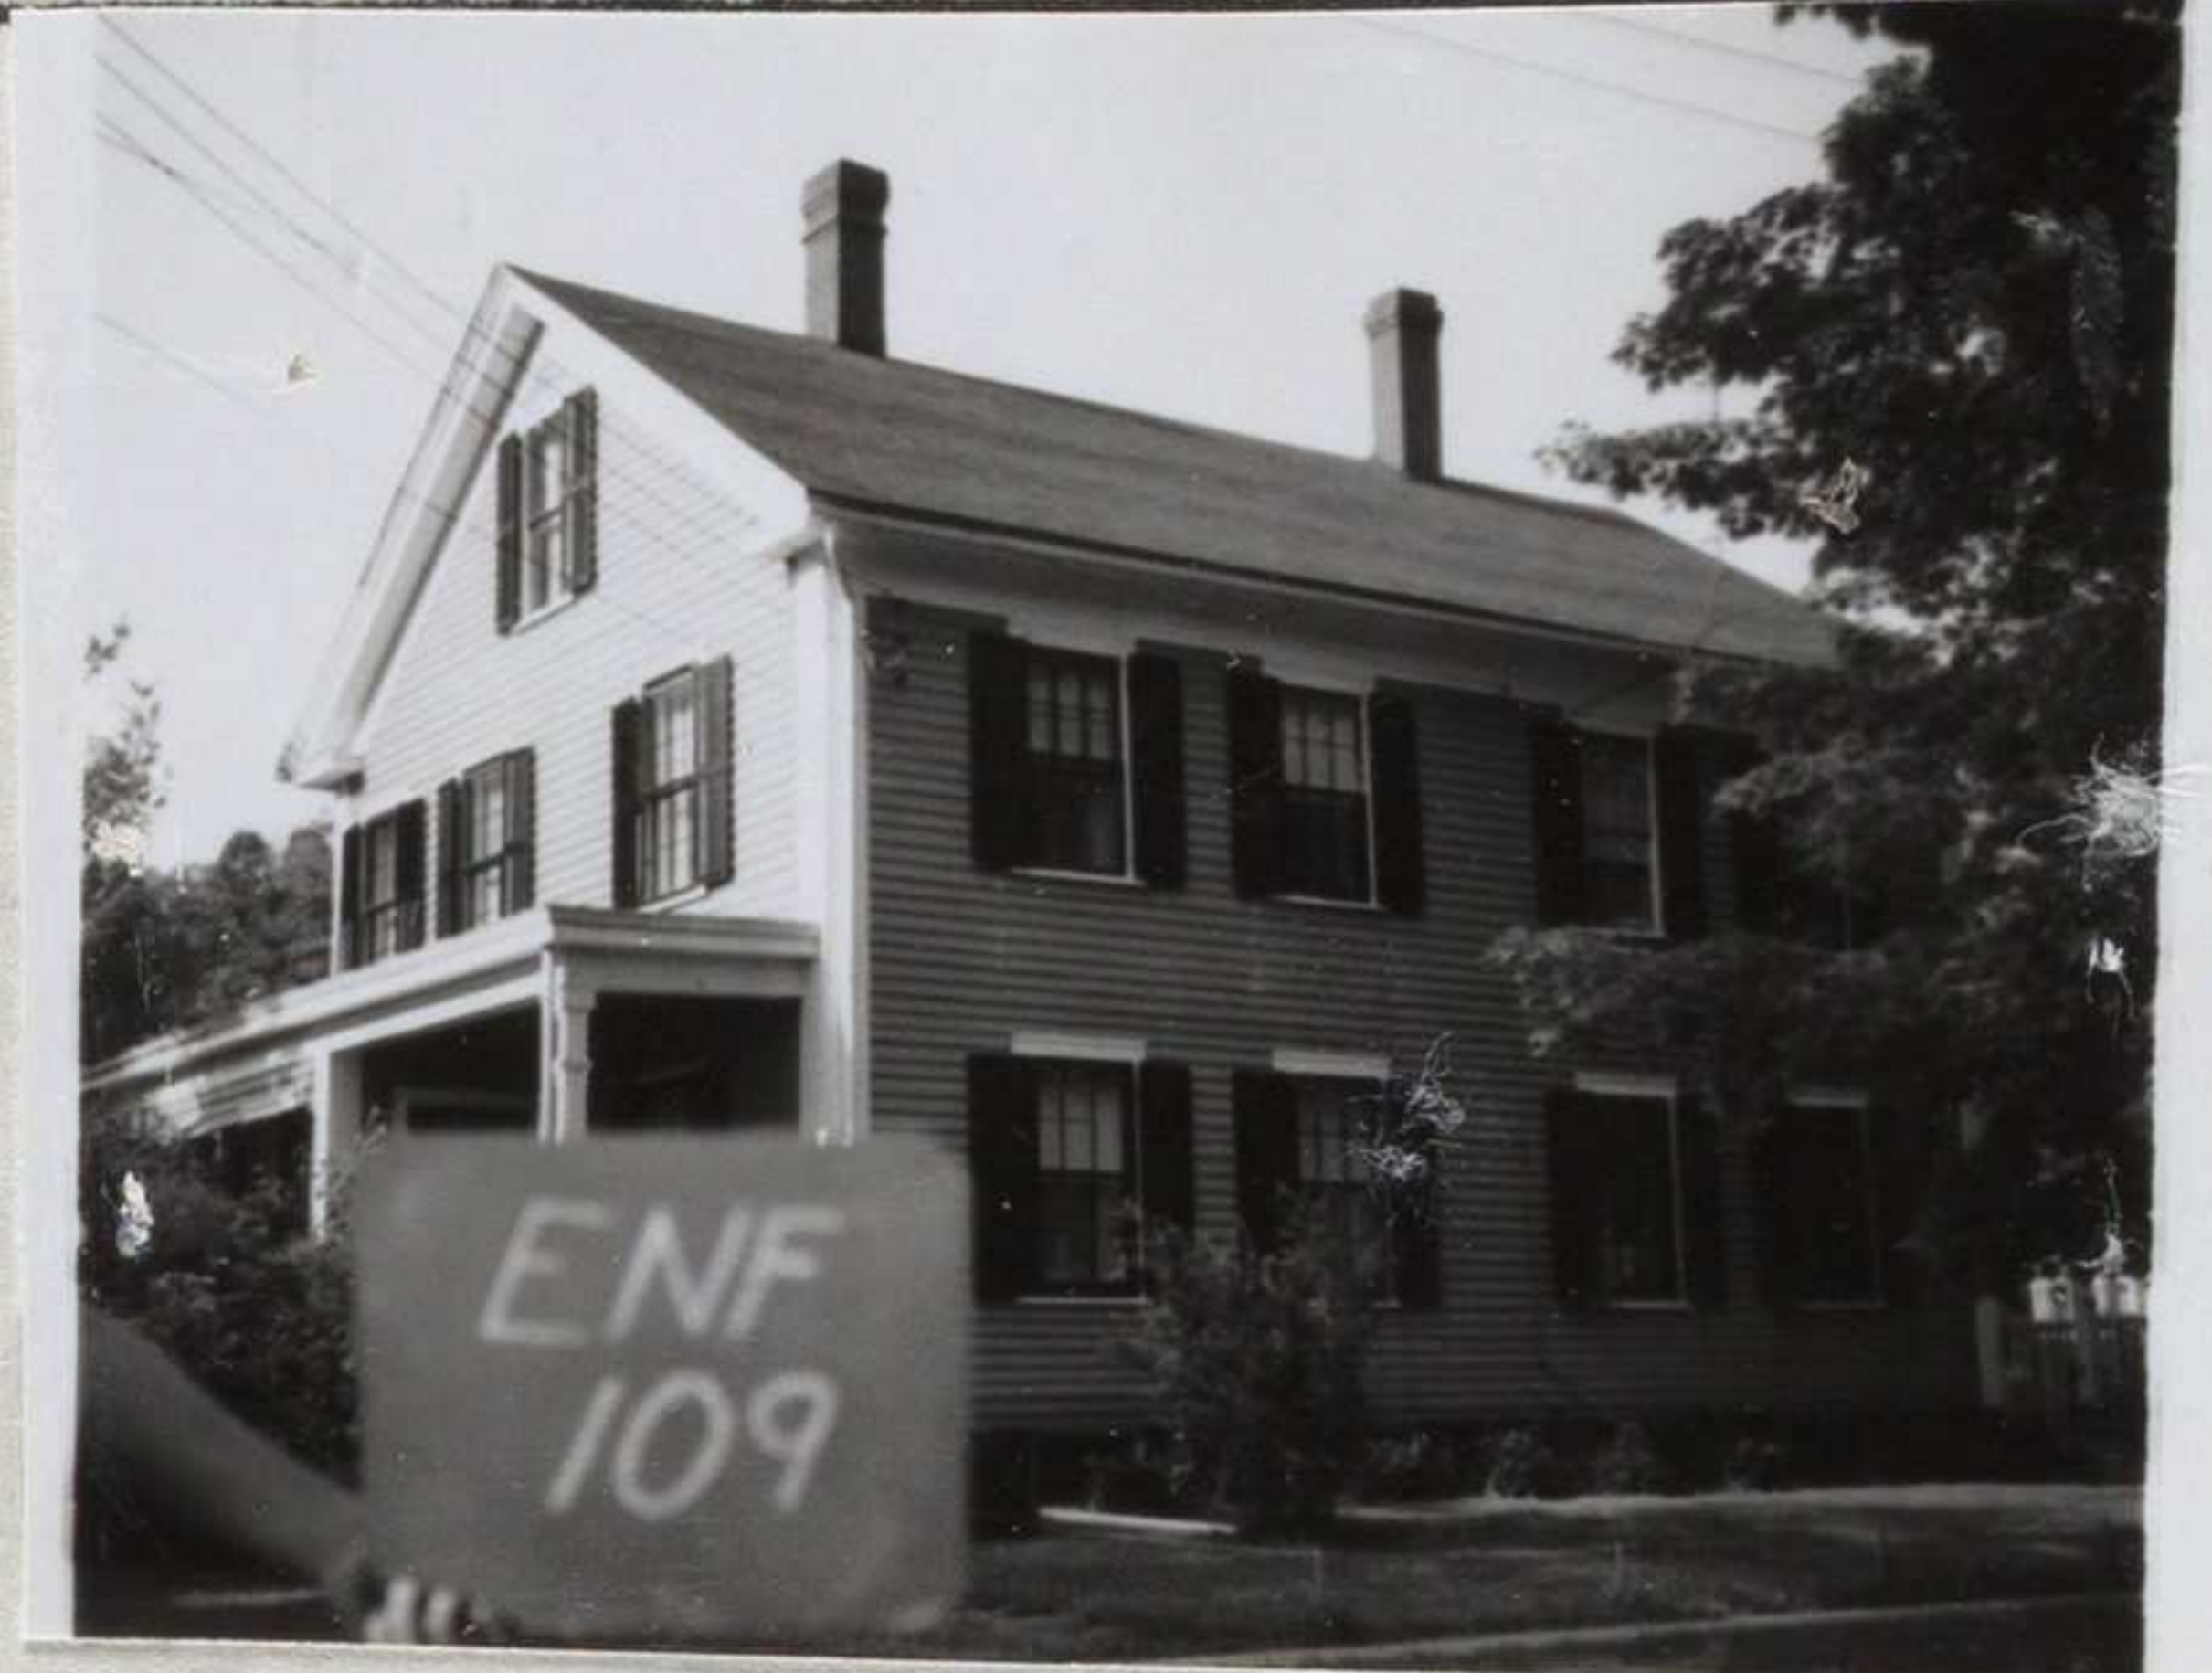
4. NOTABLE FEATURES, HISTORICAL SIGNIFICANCE AND DESCRIPTION	OPEN TO PUBLIC <i>No</i>
<i>This two family house has four bays completely made up of 6/8 windows facing the street. The doors are behind porches, opening off of side wings. Heavy corner posts rise from the brick foundation to the cornice. Chimneys are located in elevation between the 1st & 2nd and 3rd & 4th bays.</i>	
5. PHYSICAL CONDITION OF STRUCTURE	Endangered <i>No</i> Interior <i>?</i> Exterior <i>good</i>

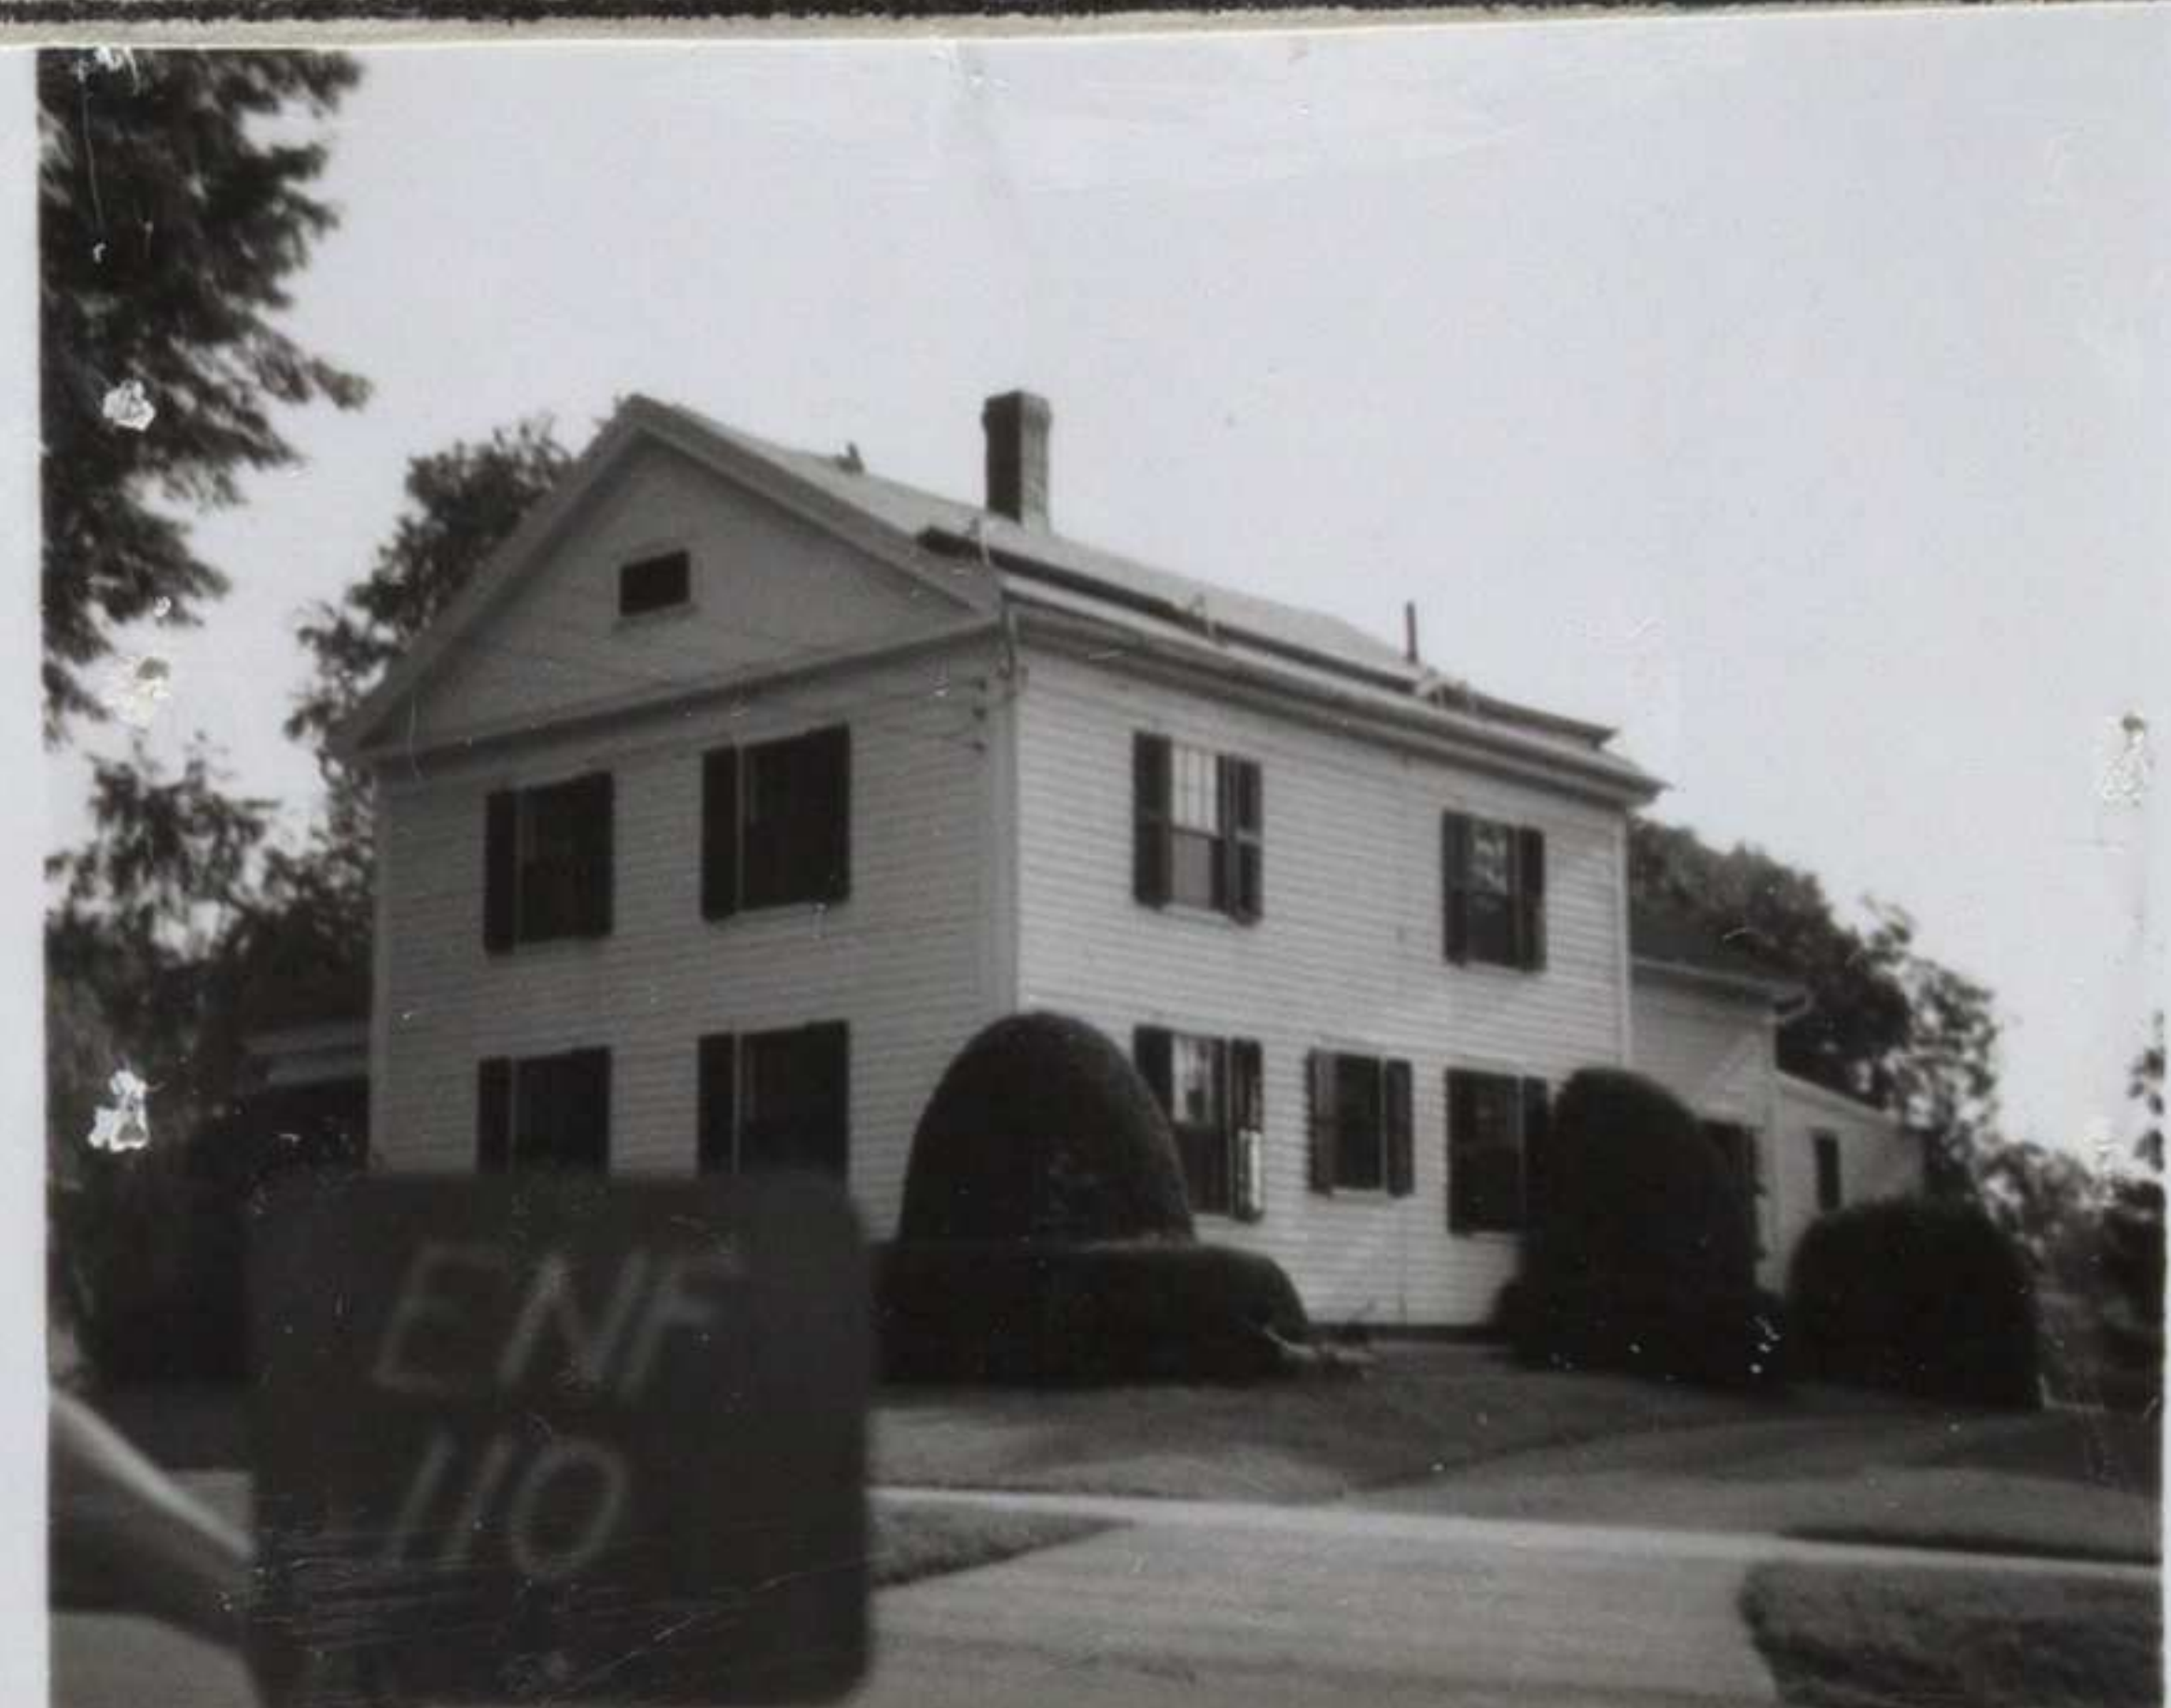
<p>7. PHOTOGRAPH <i>Enf. 110</i></p>

<p>1. STATE <i>Ct</i> COUNTY <i>Hartford</i> TOWN <i>Enfield</i> VICINITY STREET NO. <i>School Street (Hazardville)</i></p> <p>ORIGINAL OWNER? ORIGINAL USE <i>Residence</i> PRESENT OWNER? PRESENT USE <i>Residence</i> WALL CONSTRUCTION <i>clapboard</i> NO. OF STORIES <i>2</i></p>	<p>HISTORIC AMERICAN BUILDINGS SURVEY INVENTORY</p> <p>2. NAME</p> <p>DATE OR PERIOD <i>1830-1840</i> STYLE <i>Greek Revival</i> ARCHITECT BUILDER</p> <p>3. FOR LIBRARY OF CONGRESS USE</p>
<p>4. NOTABLE FEATURES, HISTORICAL SIGNIFICANCE AND DESCRIPTION</p> <p style="text-align: right;">OPEN TO PUBLIC <i>No</i></p> <p><i>Built on a brick foundation this house has a two bay pedimental facade facing the street. A shallow pitched roof forms the pediment which is plain-boarded and bears a rectangular window. The other windows are 6/6's. There are additions to the rear.</i></p>	
<p>5. PHYSICAL CONDITION OF STRUCTURE</p> <p>Endangered <i>No</i> Interior <i>?</i> Exterior <i>Good</i></p>
